Roof Condition Analysis

Judy Holstein
Terrell Plaza
1201 Austin Highway
Suite 139,
San Antonio, TX
78209

Terrell Plaza

Date: May 22, 2003

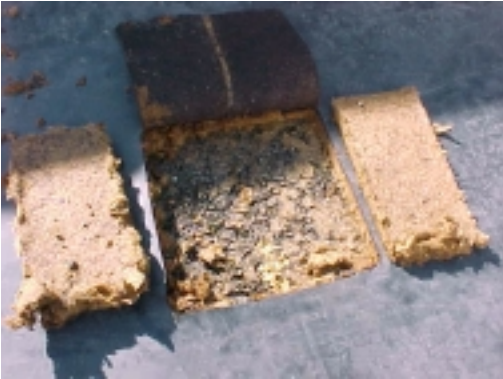
Photo #: 3

Description: Test cut to determine components.

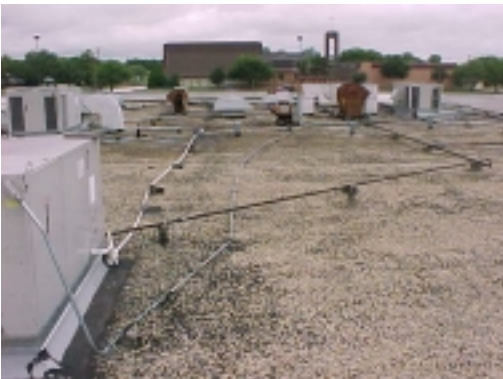
Photo #: 7

Description: HVAC Equipment

Details: This building has an excessive amount of abandoned equipment and details.

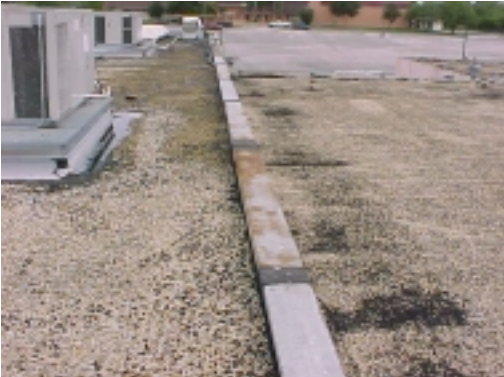
<p>Photo #: 8</p> <p>Type: Perimeter</p> <p>Description: Expansion Joint</p> <p>Membrane: Not applicable</p> <p>Flashing Metal: Painted steel</p> <p>Details: Perimeter wall detail consists of metal tie-in to BUR at the base angle change and metal cap over top of the wall. The metal cap has holes as a result of rusting.</p>

- Install 82 lineal feet of associated cast plumbing and connections to existing rainwater piping.
- Remove metal from 560 lineal feet of the complete perimeter detail and store for reuse.

- Scarify the complete perimeter membrane for a distance of 12 inches from the base of the cant and clean.
- Trim all loose roofing materials around the complete perimeter and clean.

- Apply a sandwich application of 12 inch fiberglass mesh and fibrated, asbestos-free asphalt-based mastic to the complete 560 lineal feet of perimeter detail.

- The reinforcement shall extend from the top of the cant to 6 inches onto the horizontal membrane surface.
- Apply a 4 mil polyethelene divorce layer over the fresh mastic to prevent contact of the mastic with the metal.

- Reinstall metal detail and apply new 3/8 inch gravel over the mastic on the roof surface.

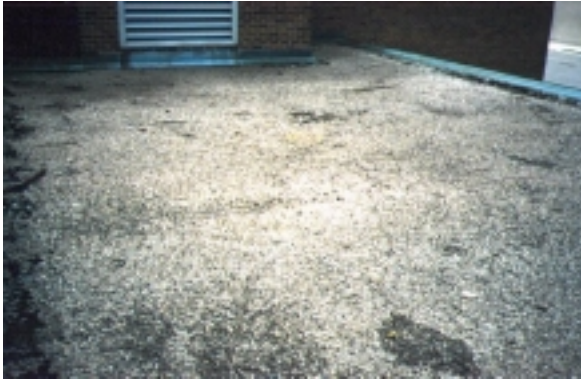
Photo #: 4

Type: Alligatoring

Severity: Moderate

Details: Alligatoring is the cracking of the surfacing bitumen asphalt which occurs during the aging process in which the loss of volatile oils and the oxidation brought about by solar radiation; produces a pattern of cracks similar to an alligator's hide. The cracks may or may not extend through the surfacing bitumen.

When alligatoring cracks extend through the entire waterproofing surface, the underlying felts can become exposed to moisture, which will progressively cause the strength in the felts to decrease. Splitting of the roof membrane may result.

- Apply a total of 900 square feet of emulsion based restorative coating to the bare felt areas in the S.E. and S.W. corners after appropriate cleaning and preparation of the membrane surface.

- Install new 3/8 inch gravel at a rate of 400 lb. per square over the fresh coating.
- Remove the ponding water conditions by installing 2 new 4 inch cast drains in the low lying areas.

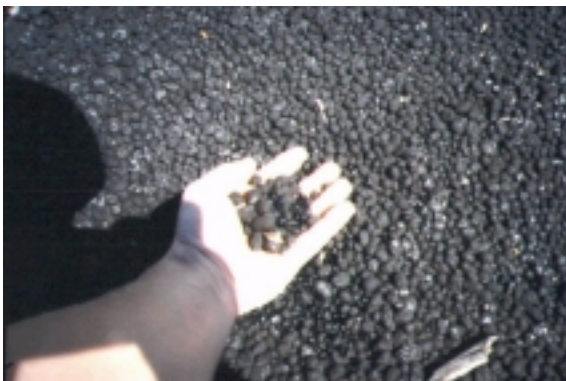
Photo #: 5

Type: Blueberries

Severity: Minor

Details: Small spherical detached pieces of asphalt. They are formed when water penetrates the top coat of asphalt; freeze-thaw cycling breaks pieces of the flood-coating loose, and the wind blows these pieces around until they are eroded into a spherical shape. Subsequently, water flow causes them to accumulate in low spots on the roof.

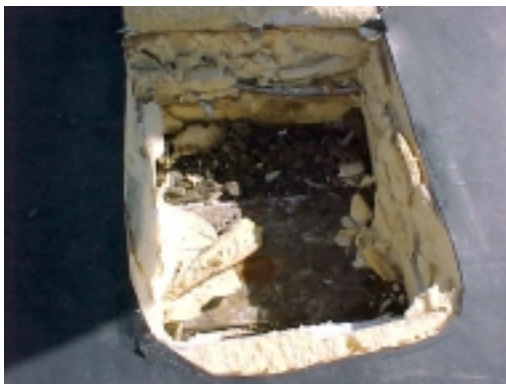
Photo: 10
Date: Jan 7, 2003
Description: Core Sample

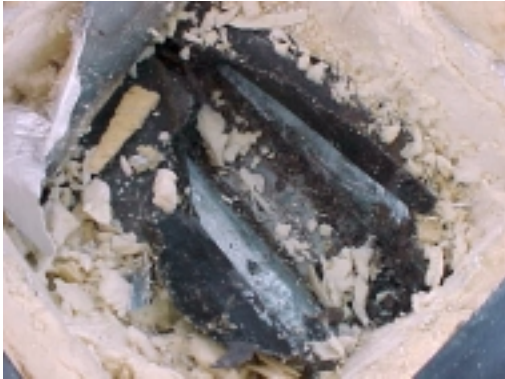
Photo #: 12

Description: Core Cut

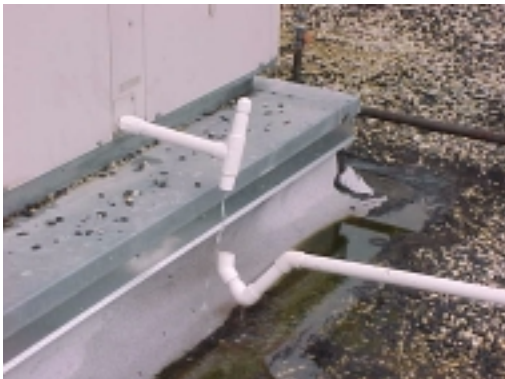
Photo #: 16

Description: Condensation Pipes

Details: Separated condensation pipes

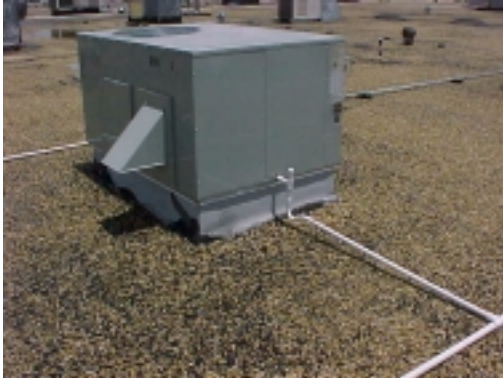
Photo #: 15

Description: HVAC equipment

Details: An excessive amount of abandoned equipment curbs are present. These details are in bad condition.

With the abandoned equipment curbs, pitch pockets were installed for electrical service to the equipment. The material in the pitch pockets is cracked allowing water to enter into the building. The pitch pans are not full, allowing water to gather on top of the cracked material.

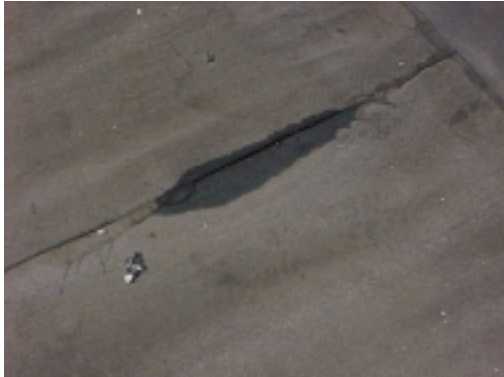
Photo #: 13

Type: Open seam

Severity: Moderate

Details: Water appears to be penetrating seams of the modified section (over first floor roof area).

- Tie-in new roofing to old membrane with additional two plies of 12 inch wide felt centered on the leading edge of the new roofing. Apply new 3/8 inch gravel at a rate of 400 lb. per square onto the new roofing.
- Repair a total of 29 identified blisters in the membrane in accordance with standard NRCA blister repair procedures.

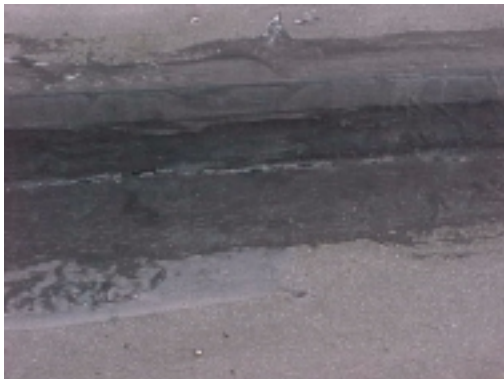
Photo #: 14

Type: Splits @ expansion detail

Severity: Moderate

Details: Splits in material at the expansion detail between the roof areas on the first floor roof.

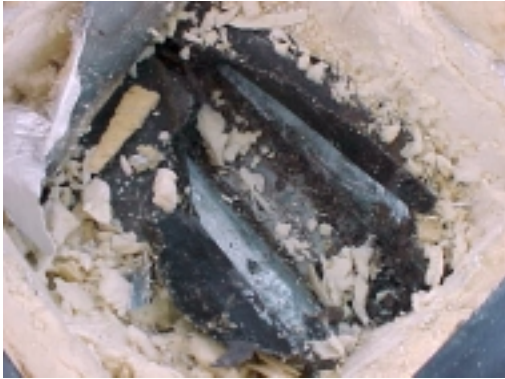
Photo: 12

Description: Confirmation damp area

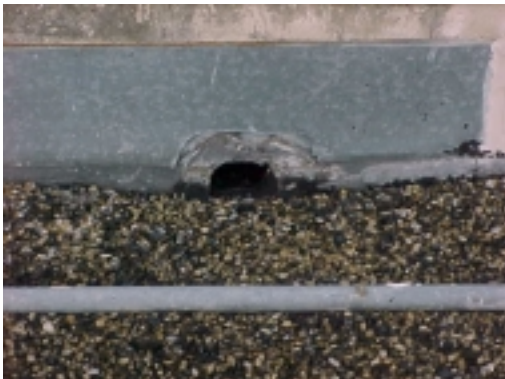
Photo #: 23

Description: External scupper

Details: Scuppers installed every 6' along SW wall. Appear to be performing as intended.

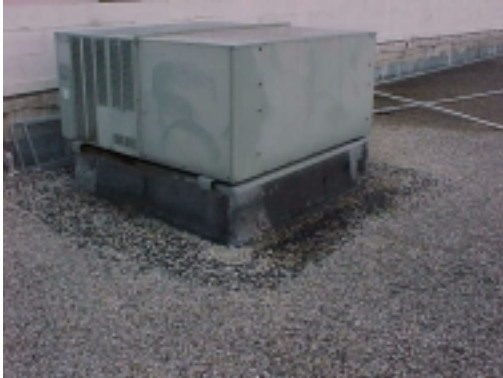
Photo #: 24

Description: HVAC

Details: HVAC curb details appear to be performing as intended. Condition looks good.

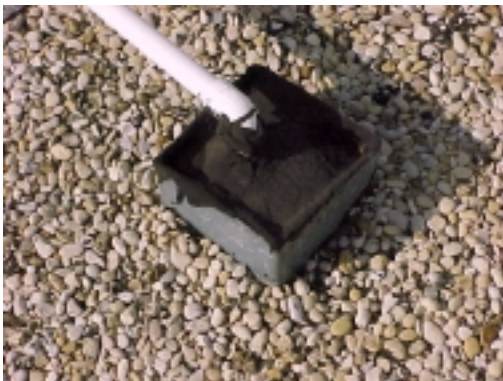
Photo #: 25

Type: Pitch Pan

Details: Pitch pans are in bad condition. Cracks/voids are in the pitch material and the pans were not filled. Water is contained over the cracked material allowing water to infiltrate the building.

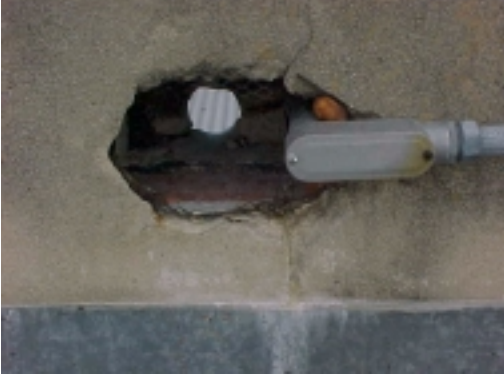
<p>Photo #: 20</p> <p>Type: Hole in block wall (unit 165)</p> <p>Severity: Major</p> <p>Details: This hole was placed in the wall for installation of non-roof related items. Holes remain following the removing of the installed items.</p>

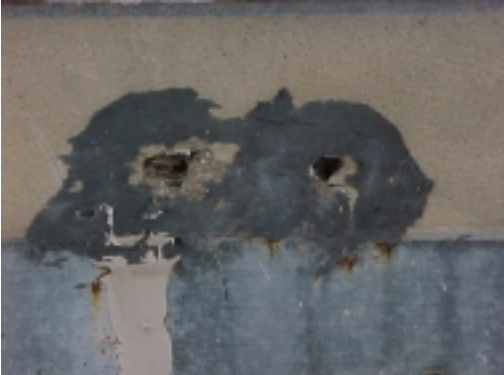
<p>Photo #: 21</p> <p>Type: Hole in wall (unit 165)</p> <p>Severity: Major</p> <p>Details: Hole was placed in parapet wall for the installation of electrical conduit. This would be a major source of water infiltration into the building structure.</p>

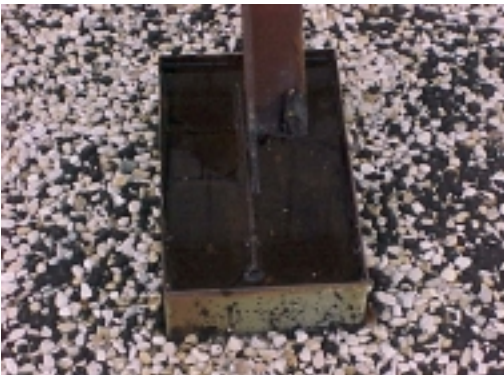
<p>Photo #: 22</p> <p>Type: Pitch pocket with void/cracks</p> <p>Severity: Major</p> <p>Details: Pitch pans have voids/cracks in the pitch material. Pans were not filled to the top, therefore are holding water. The cracks/voids will allow water to infiltrate the building.</p>

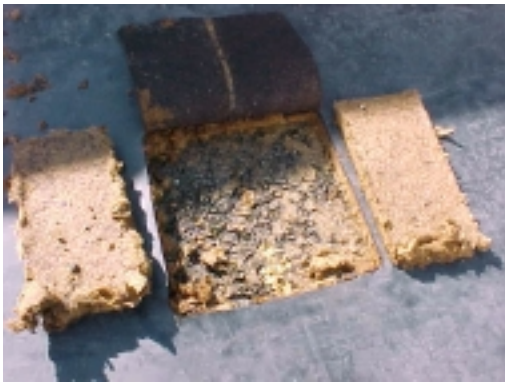
Photo: 3

Description: Confirmation damp area

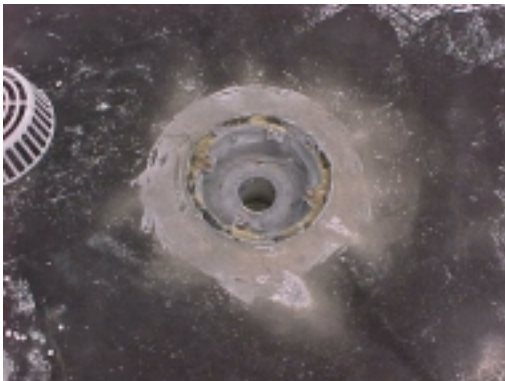
Photo #: 31

Description: Interior drain

Details: Interior drains appear to be performing as intended.

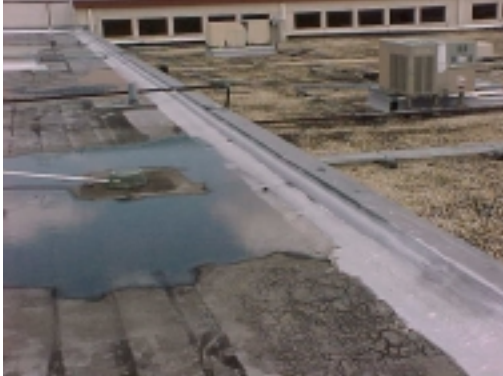
Photo #: 32

Description: Expansion Joint

Details: Voids/splits in expansion joint material. Expansion joint was coated recently, but this repair is inadequate. Splits in the rubber base material cannot be repaired using a paint/coating.

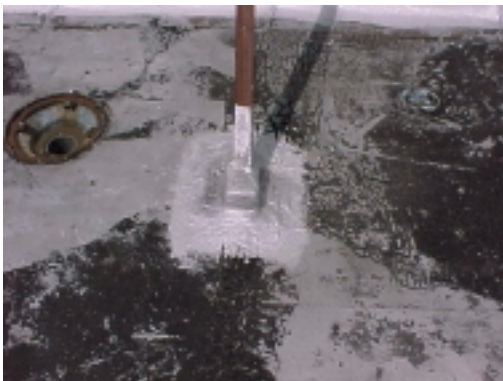
Photo #: 28

Type: Pitch pockets

Severity: Major

Details: Material in pitch pocket has voids/cracks. Possible source of water entry into the building interior.

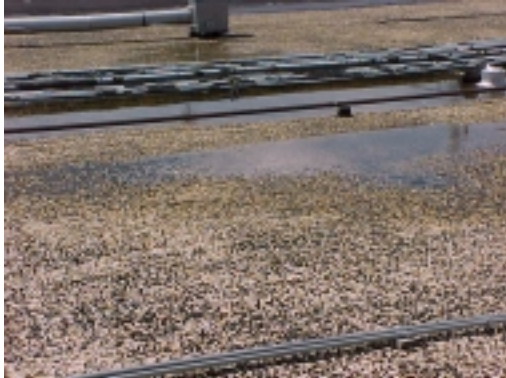
Photo #: 30

Type: Ponding

Severity: Major

Details: Ponding water can be traced to any of several factors. First, a roof may pond water as a result of poor housekeeping on the roof which contributes to clogged drains, gutters and downspouts. The build up of roof top debris or displaced gravel ballast frequently blocks water flow and creates ponds. Secondly, the building's roof top drainage system may not have been designed properly. Finally, ponds form as a result of such common conditions as building settlement and deck deflection.

We recommend complete tear-off and replacement of the roof. Remove all roofing materials down to the deck and then install a new roof in the following manner:

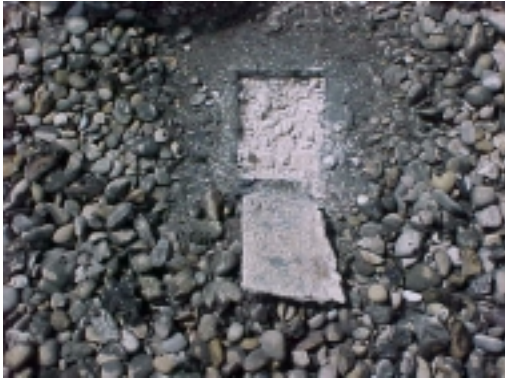
Photo: 19

Description: Confirmation damp area
