Roof Repair Proposal

Judy Holstein
Terrell Plaza
1201 Austin Highway
Suite 139,
San Antonio, TX
78209

Building A

Inspection Date: January 05, 2003

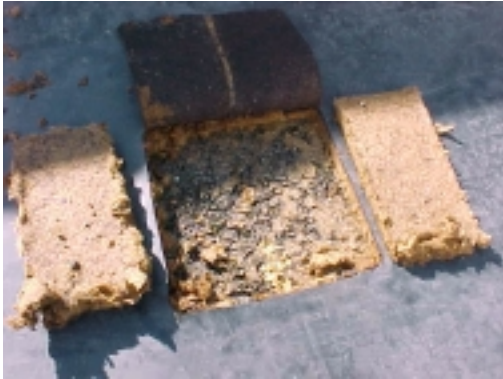
Photo #: 3

Description: Test cut to determine components.

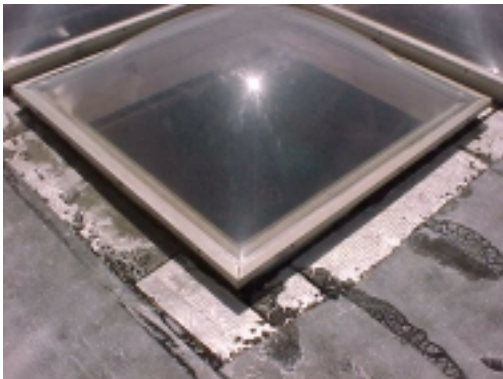
Photo #: 6

Description: Skylights

Details: The expansion joint metal has voids at the joints of the metal work. Previous repairs were completed, but these repairs are failing.

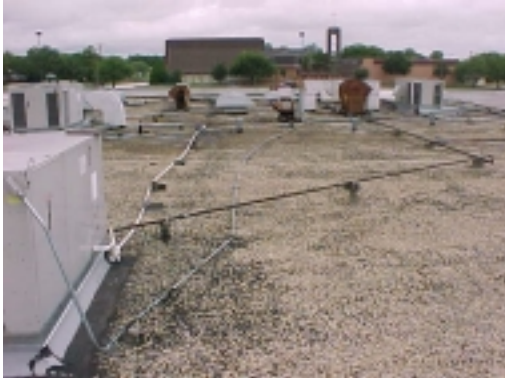
Photo #: 7

Description: HVAC Equipment

Details: This building has an excessive amount of abandoned equipment and details.

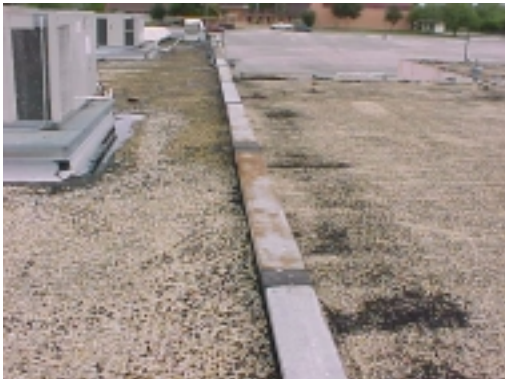
Photo #: 8

Description: Expansion Joint

Details: Perimeter wall detail consists of metal tie-in to BUR at the base angle change and metal cap over top of the wall. The metal cap has holes as a result of rusting.

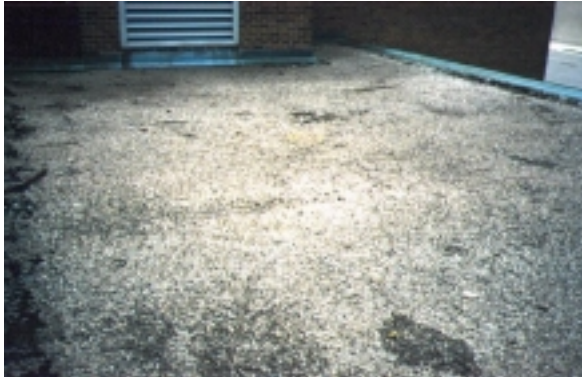
Photo #: 4

Type: Alligatoring

Severity: Moderate

Details: Alligatoring is the cracking of the surfacing bitumen asphalt which occurs during the aging process in which the loss of volatile oils and the oxidation brought about by solar radiation; produces a pattern of cracks similar to an alligator's hide. The cracks may or may not extend through the surfacing bitumen.

When alligatoring cracks extend through the entire waterproofing surface, the underlying felts can become exposed to moisture, which will progressively cause the strength in the felts to decrease. Splitting of the roof membrane may result.

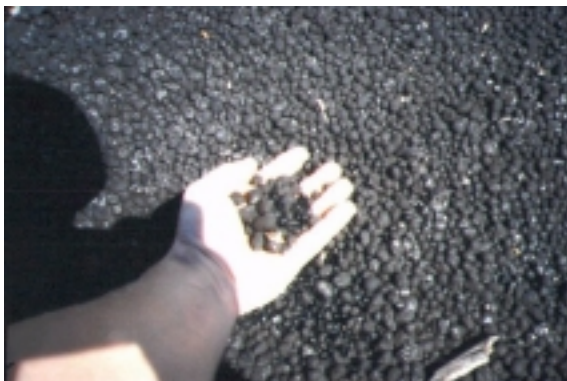
Photo #: 5

Type: Blueberries

Severity: Minor

Details: Small spherical detached pieces of asphalt. They are formed when water penetrates the top coat of asphalt; freeze-thaw cycling breaks pieces of the flood-coating loose, and the wind blows these pieces around until they are eroded into a spherical shape. Subsequently, water flow causes them to accumulate in low spots on the roof.

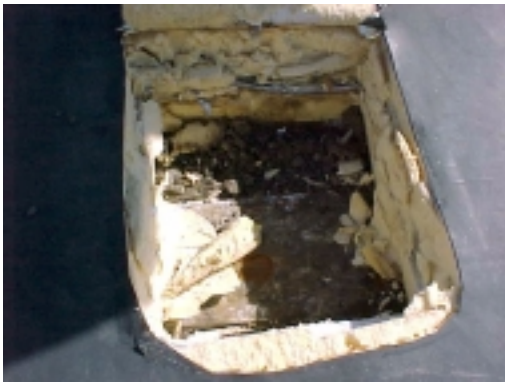
Photo: 10

Description: Core Sample

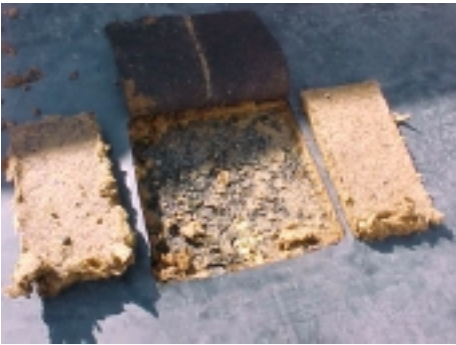
#	Description	Annotation
1	Terrell Plaza	Building exterior of building A.
2	Roof Section A	Partial overview of Building A
3	Test cut	Test cut completed. Determined components of system.
4	Alligatoring	Alligatoring found on this roof section
5	Blueberries	Blueberries on roof section A
6	Skylight	Close-up of skylight detail. All of these skylights have exposed metal flashing and are not watertight.
7	Abandoned Equipment	
8	Expansion Joint	Metal cap detail showing rusted areas.
9	Pitch pans	Overview of pitch pans that hold water and have voids/cracks.
10	Core Cut	Core Cut
11	Roof Section B	Partial overview of buiding B.
12	Test Cut	Core cut to determine roof composition
13	Open Seam	Water leaking through open seam
14	Splits	Splits at expansion detail
15	HVAC Equipment	Abandoned HVAC

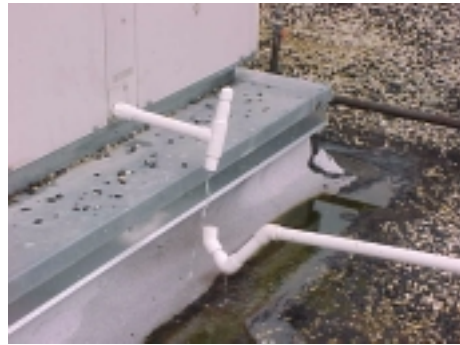
#	Description	Annotation
16	Separated condensation pipes.	Separated condensation pipe allowing water to drain onto roof.
17	Expansion Joint	Deteriorated expansion joint
18	Building C	Overview of Building C
19	Core Cut	Test cut to determine composition of the roof
20	Hole in Wall	Hole through parapet wall on building C @ unit 165.
21	Holes in Wall (2)	Holes in parapet wall on building C @ unit 165.
22	Pitch pans	Pitch pans with cracks/voids hold water.
23	Scuppers	Scupper detail on building C.
24	Unit Detail	Typical unit detail of building C.
25	Pitch pocket	Pitch pocket - typical.
26	Roof Section D	Overview of section D
27	Test Cut	Core cut to determine composition
28	Pitch Pans	Painted pitch pockets over unit 133.
29	Pitch pockets	Pitch pocket with cracks/voids, possible source of water infiltration into the interior.
30	Ponding	Excessive ponding of water on building D.
31	Drain	
32	Expansion Joint Detail	Expansion joint detail on modified bitumen roof level on building D.

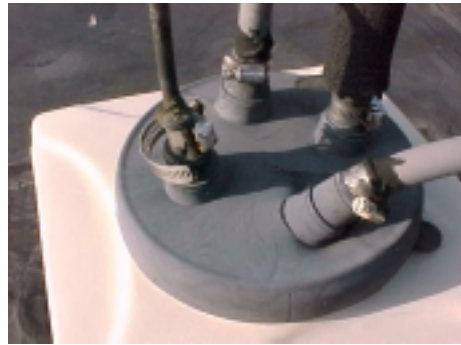
39	HVAC detail	HVAC unit curb detail.
41	Flashing	Flashing by others, typical of penetrations for service to a/c units. Cracks present on all of these pre-fabricated boot type details.
42	Fan Detail	
43	Holes in wall	Voids in junction of wall and metal cap. Possible source of water entry.
44	Scuppers	Scuppers every 6'
45	Alligating	
46	Scuppers	Scupper detail on building C.
