Roof Condition Analysis

Judy Holstein
Terrell Plaza
1201 Austin Highway
Suite 139,
San Antonio, TX
78209

Terrell Plaza

Date: May 22, 2003

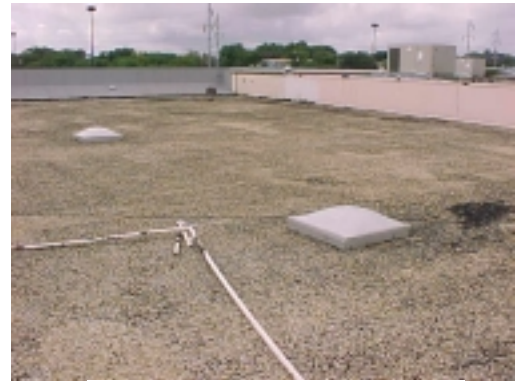
Designation: A

Condition Index: Poor

Currently Leaking? Yes

History of Leaking? Yes

Drainage and Leak Details: Leak detected after heavy rains. Has also leaked in the past.

The waterproofing capabilities of the roof membrane would appear to be inadequate at this point in time.

Type of Activity	Urgency	\$
Repair	High	\$10,563

We recommend the following roof repairs. Roof work will be performed in the following manner:

- Cut out and replace 200 square feet of wet insulated roofing adjacent to the large HVAC unit.
- Scarify adjacent existing roof for a distance of 18 inches and prepare the surface for tie-in with new roofing materials.

- Apply new 3/8 inch gravel at a rate of 400 lb. per square onto the new roofing.
- Repair a total of 29 identified blisters in the membrane in accordance with standard NRCA blister repair procedures.

- Install new 3/8 inch gravel at a rate of 400 lb. per square over the fresh coating.
- Remove the ponding water conditions by installing 2 new 4 inch cast drains in the low lying areas.

- Scarify the complete perimeter membrane for a distance of 12 inches from the base of the cant and clean.
- Trim all loose roofing materials around the complete perimeter and clean.

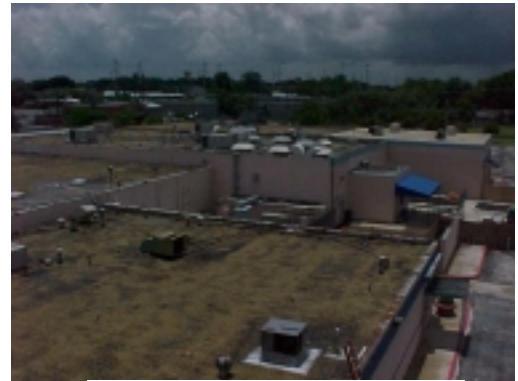
Roof is need of repair ASAP

Type of Activity	Urgency	\$
Repair	Moderate	\$5,250

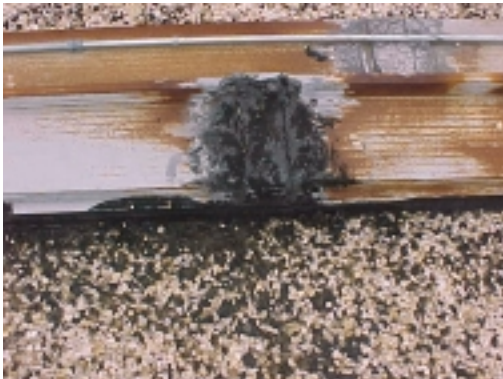
Photo #: 48

Details: An excessive amount of abandoned equipment curbs are present. These details are in bad condition.

With the abandoned equipment curbs, pitch pockets were installed for electrical service to the equipment. The material in the pitch pockets is cracked allowing water to enter into the building. The pitch pans are not full, allowing water to gather on top of the cracked material.

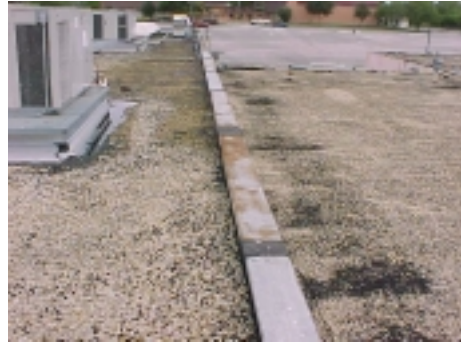
8

<p>Photo #: 8</p> <p>Type: Perimeter</p> <p>Description: Expansion Joint</p> <p>Membrane: Not applicable</p> <p>Flashing Metal: Painted steel</p> <p>Details: Perimeter wall detail consists of metal tie-in to BUR at the base angle change and metal cap over top of the wall. The metal cap has holes as a result of rusting.</p>
