Roof Repair Proposal

Judy Holstein
Terrell Plaza
1201 Austin Highway
Suite 139,
San Antonio, TX
78209

Building A

Inspection Date: January 05, 2003

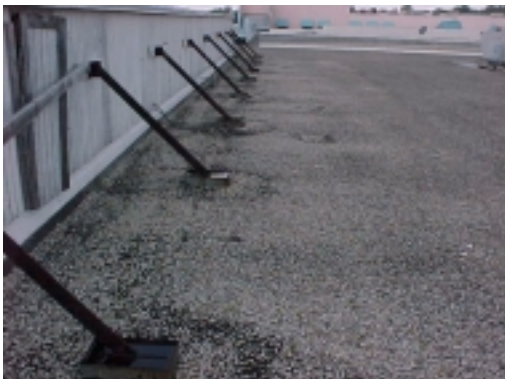
Photo #: 9

Details: Perimeter wall detail consists of metal tie-in to BUR at the base angle change and metal cap over top of the wall. The metal cap has holes as a result of rusting.
